Effects of Concentrated Hydrochloric Acid Spills on Aircraft Aluminum Skin

July 1998

DOT/FAA/AR-TN97/108

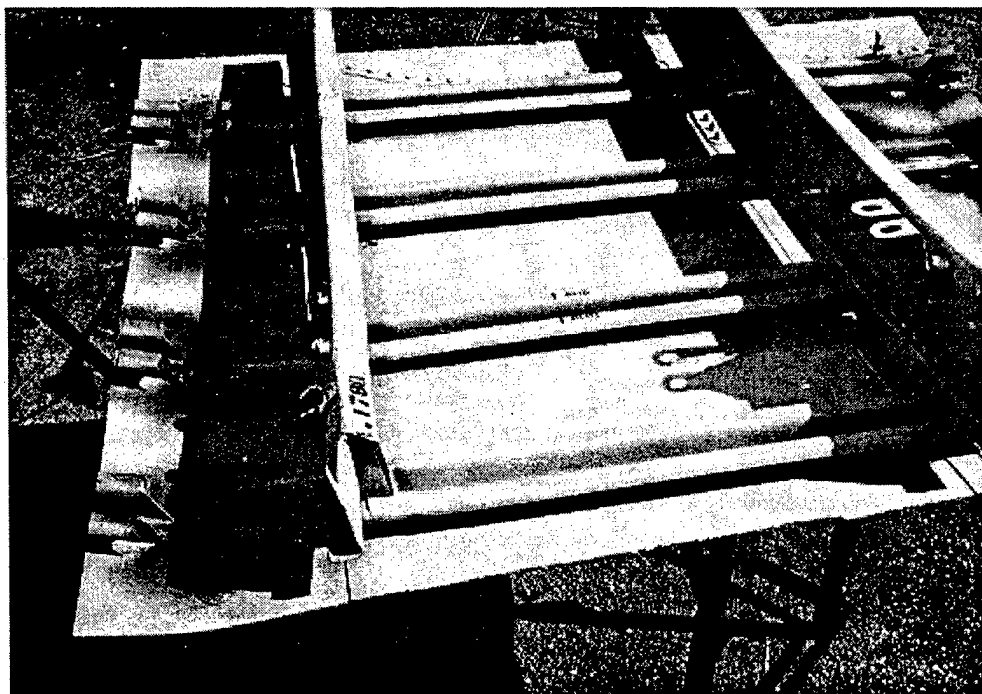
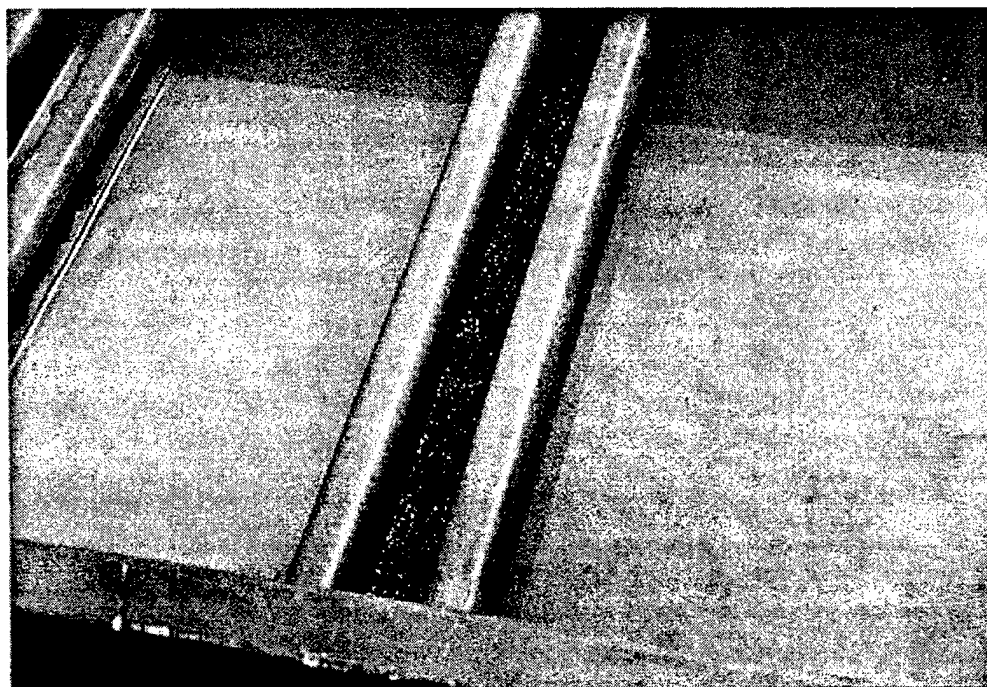
The first test was the largest, a 3- by 3-foot section with a 1-liter acid spill (figures 1 and 2). The edges of the skin were bent upwards to contain the acid. In the process of bending the skin and cutting notches in the ribs to allow the bending of the frame, scrapes and breaks in the surface coating of the aluminum skin were produced. There was no treatment of the marred surfaces in this test. The acid contacted not only the interior skin surface but also the bulkhead plates and fittings and the ribs and attaching grommets.

FIGURE 1. TEST ARTICLE FOR TEST 1: 3- BY 3-FOOT SIDEWALL OF A BOEING 747

FIGURE 2. TEST 1 IN PROGRESS WITH A 1-LITER SPILL OF CONCENTRATED HYDROCHLORIC ACID

Test No.	Test Article Description	Location of Failure	Time to Failure (min.)	Comments	Figure No.
1	3' x 3' section of fuselage	At scratched surfaces and at bends in skin At rivets	47, 65, and 80 No failure	Acid created hole in skin at scratched and bent surfaces. Rivets partially decomposed, but still intact.	1, 2
2	6" x 6" section of aluminum skin in a 7" x 7" Pyrex pan	At rivets At ribs At rivets	50 70 80 85	Three rivets eaten away below surface of skin. Side of rib eaten 1/2 inch through the length of rib. Severe corrosion. All submerged surfaces of unpainted rib completely gone. Only white exterior paint remained where rivets were.	3
3	7" x 7" section of aluminum skin as base of pressurized box, 0-2.5 psi. Silicone caulk used as a seal.	At rivets At ribs	N/A 90	Severe corrosion. Rivets eaten through below surface of the skin. Rib disconnected from aluminum skin. All submerged surfaces of unpainted rib completely gone. Base seal remained intact. Pressure not maintained during the test due to failure of lid seal.	4, 5, 6

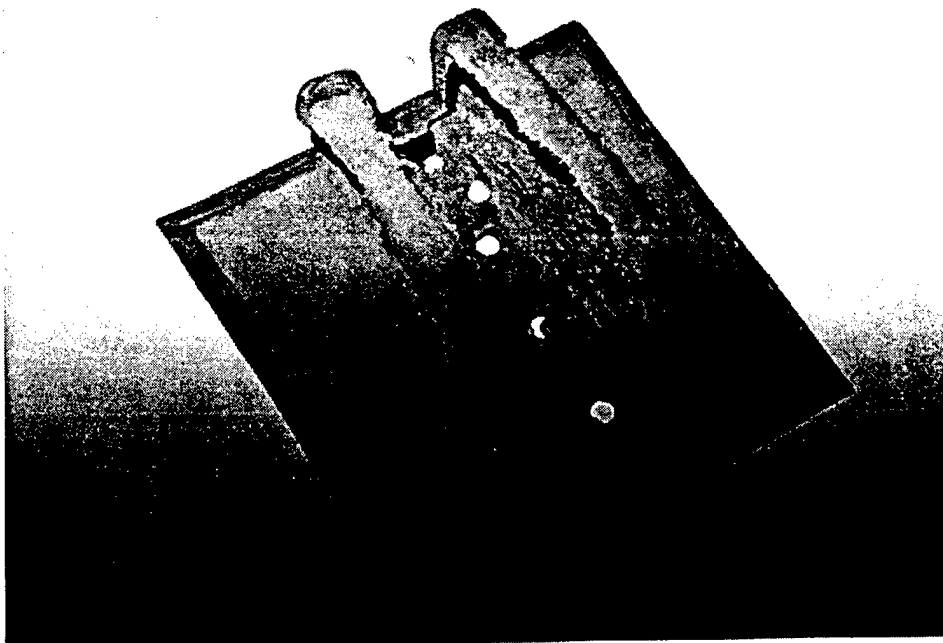
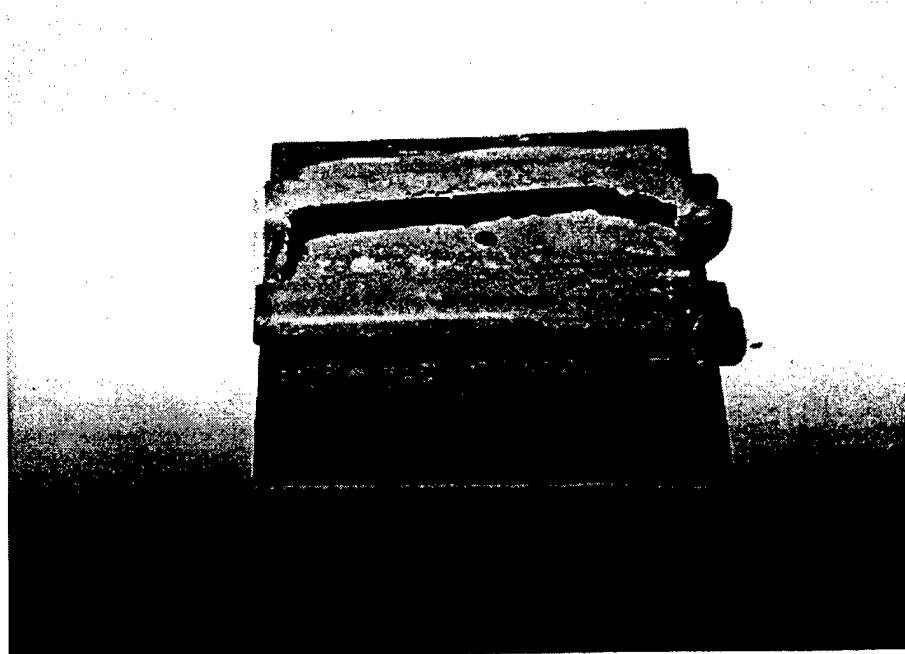
A 6- by 6-inch section of the skin, including the frame material, was placed in a Pyrex pan with the outside surface of the skin face down. All cut edges of the test sample were covered with epoxy paint. One liter of concentrated HCl was spilled into the Pyrex pan. The depth of acid was 1 1/4 inches. Periodically the section of skin was lifted out of the solution with metal tongs to visually evaluate the damage as a function of exposure time. The test specimen was rinsed with tap water at the conclusion of the test and photographed (figure 3).

**FIGURE 3. TEST ARTICLE FOR TEST 2 AFTER REMOVAL FROM PYREX PAN
CONTAINING 1 LITER OF CONCENTRATED HYDROCHLORIC ACID, TWO VIEWS**

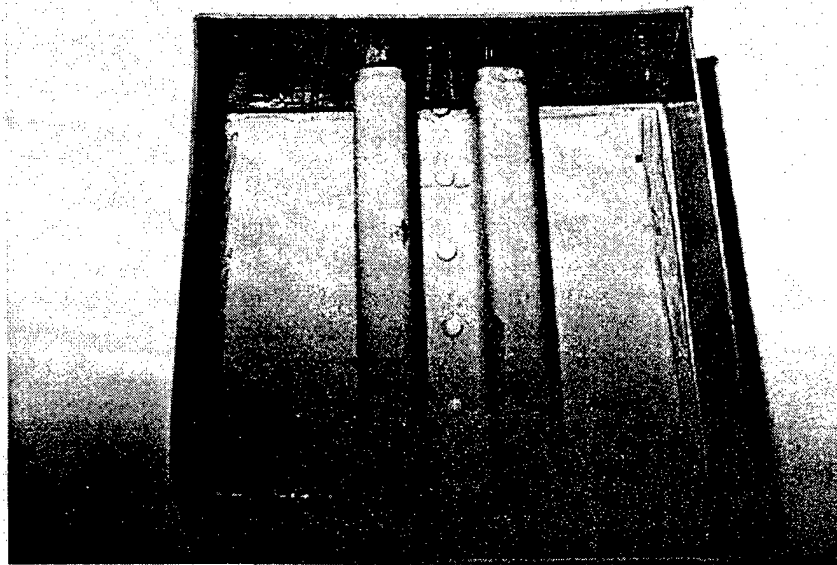
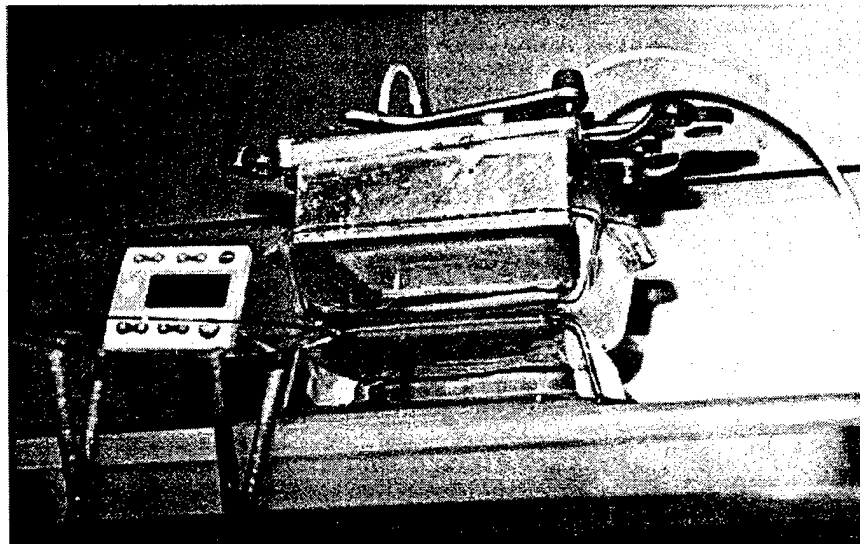
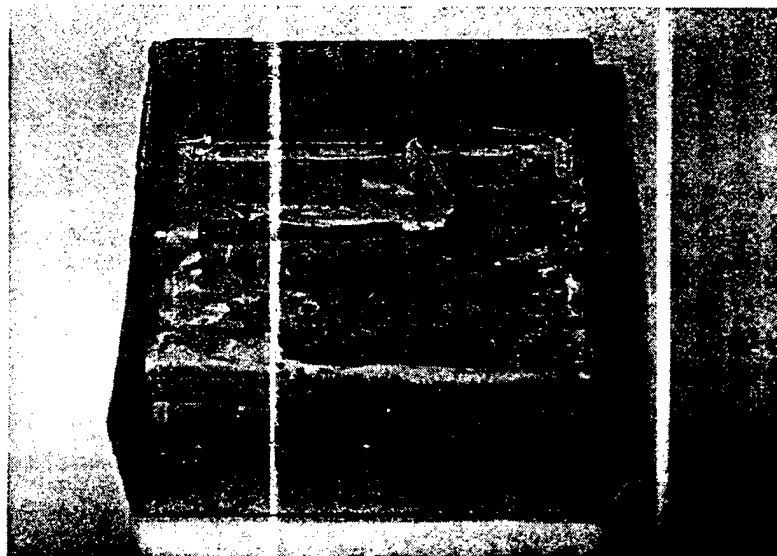
FIGURE 4. TEST ARTICLE FOR TEST 3 PRIOR TO ACID SPILL

FIGURE 5. TEST 3 IN PROGRESS WITH A 1-LITER SPILL OF CONCENTRATED HYDROCHLORIC ACID

FIGURE 6. TEST ARTICLE FOR TEST 3 AFTER A 90-MINUTE CONTACT WITH SPILLED CONCENTRATED HYDROCHLORIC ACID. TOP OF TEST CONTAINER REMOVED.

A 2.5 psi box pressure simulates the ΔP_{skin} at 15,000 feet altitude. A small ΔP may result in the blowout of the white exterior epoxy paint on the bottom of the box when the rivets fail, giving a visual indication of failure. However, the silicone lid seal failed early into the test and pressure fell to ambient.
